The 1969 Flood and Coastal Erosion on Cape Pitsunda

Olga Yakushenko

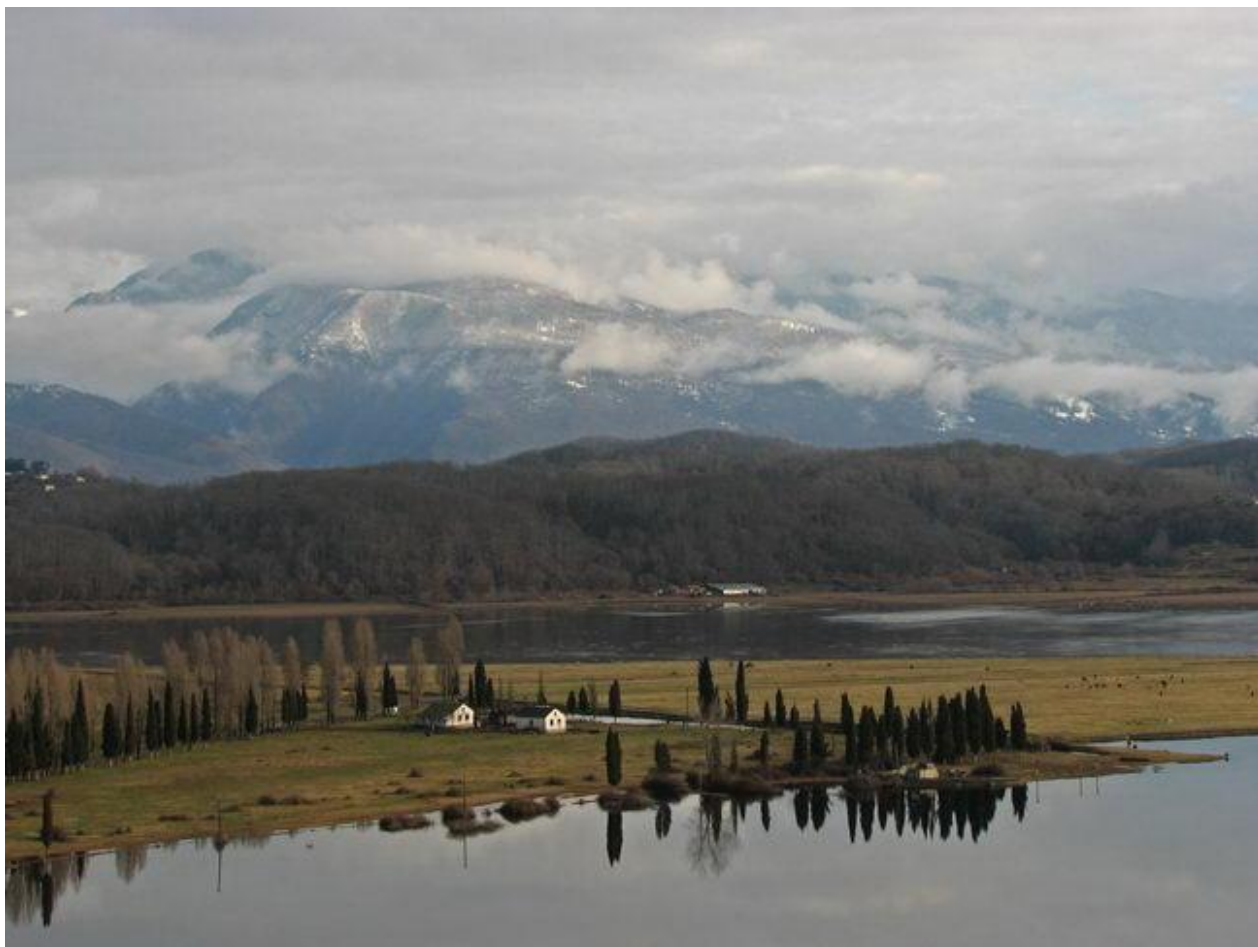
View of Cape Pitsunda after the coastal reconstructions.

The research team then began a closer study of the beach itself. They found that the erosion had exposed the layers of clay at beneath the shingle. These were quickly destroyed once the shingle was gone. They also noticed that the coast on the other side of the river was not only unaffected by erosion, it was even continuing to grow outwards into the water. The cause was found in the mouth of the Bzyb River, which had previously been used for industrial pebble quarrying. After one storm, the river changed course and began to wash away the open-cast mines; one side was therefore reinforced with a concrete wall. As a result, the shingle and sand that made up the beach and protected the coast from erosion washed away only on one side. The clay of the Pitsunda beach slowly lost its protective layer; the storm of 1969 only finished a process that human beings had unknowingly begun. In the 1980s, the Pitsunda beach was reconstructed with the help of specially imported gravel and sand. The long story of the reconstruction shows the destructiveness of unthinking human interference in a complex natural system.
